# BUCKLING OF ROOF FLASHINGS

Rod Newbold (Commercial Manager, Steel & Tubing Roofing Products),  
John Turner (Wood Technologist, SCION)

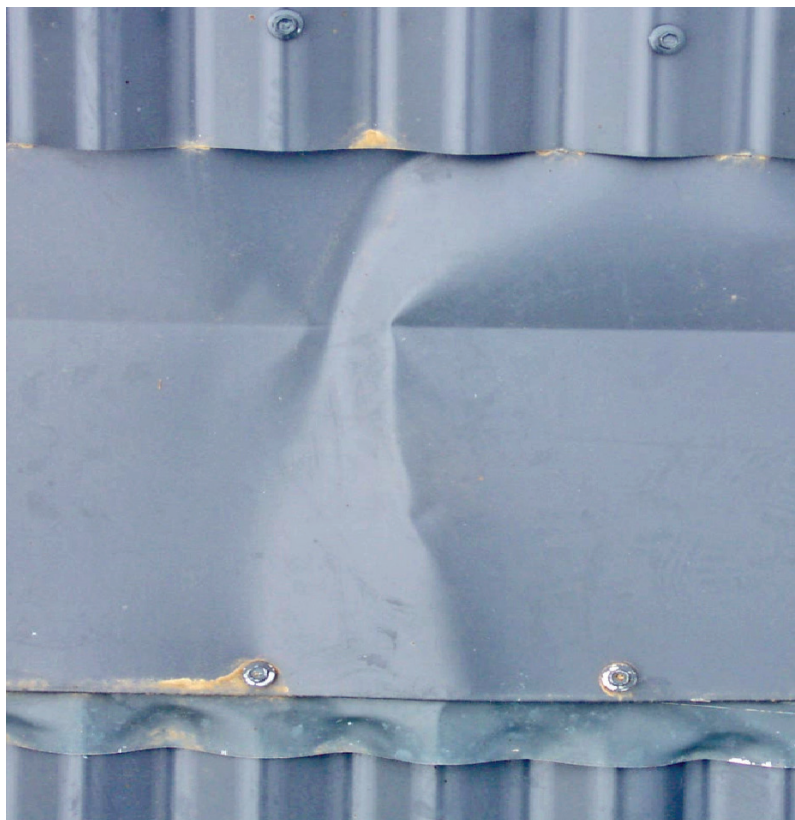
There has been a spate of compression buckling of transverse roof flashings, such as ridges, aprons, and apex barges, over recent years. The buckling can be seen in a number of forms, from a series of ripples along the length of the flashing, to a total collapse where the material is pleated and one face overlaps the other (Figure 1 and 2).

Figure 1 Buckled ridging

Do not fasten transverse flashings to timber members that have an mc in excess of 18%. A lower moisture content would be better but takes longer drying time. (BRANZ reports indicate a roof-space average emc of 9%),

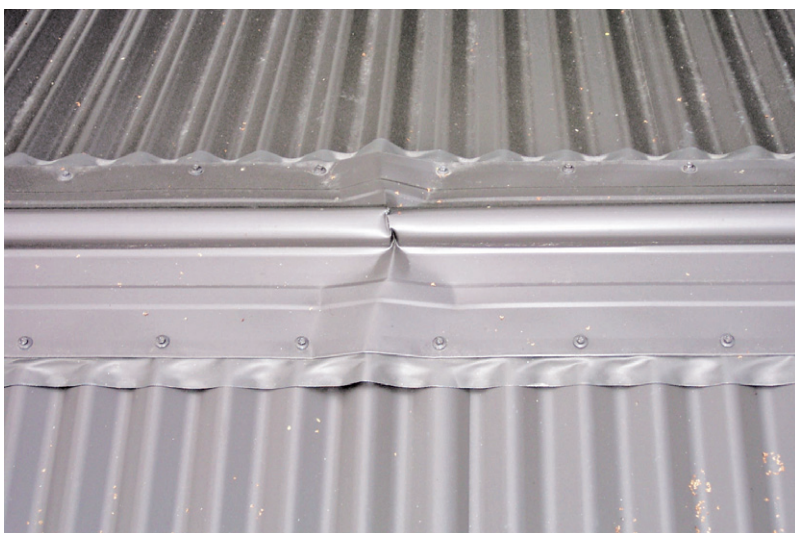
Figure 2 Buckled change of pitch flashing

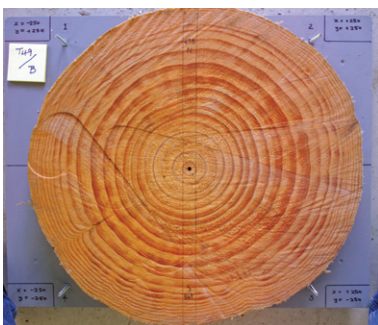
Compression Wood was formerly associated with trees growing with a lean, that developed the ability to expand along the grain while being formed, thus slowly bending the stem back to a vertical position. With recent plantation growing techniques this wood type appears more common, which due to wider spaced planting and high pruning, can be subject to wind stress from all sides. Consequently Compression Wood can appear all round the cross-section of the trunk not just the under-side of leaning trees. Figures 3

Figure 3 Compression wood all round the stem cross-section.

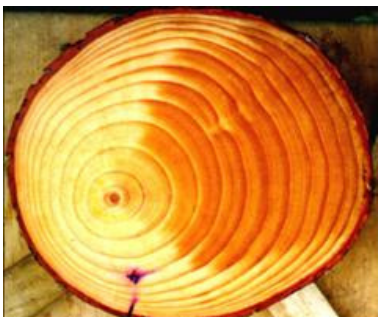
Figure 4 : Compression wood in leaning stems, severe,.

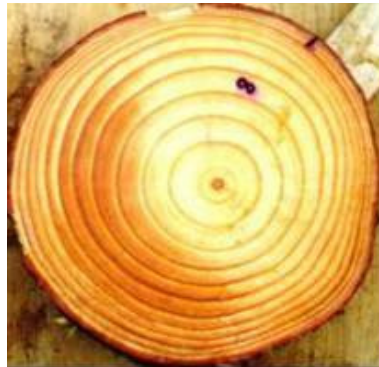
Figure 4.1 : Compression wood in leaning stems, moderate.

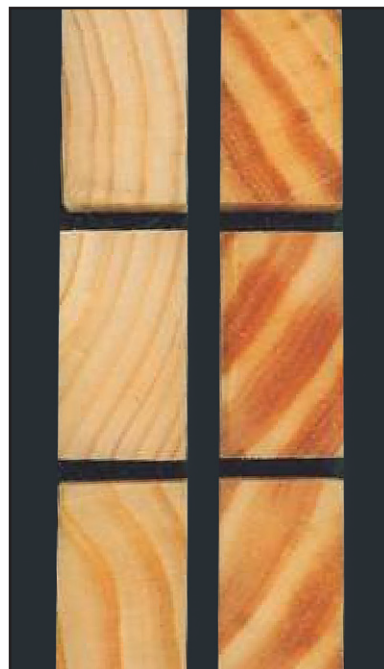
Compression wood has a darker appearance in the early wood (summer) growth rings (Figure 4&5) and a different cell shape to normal wood (Figure 6). It is not easy

Figure 5 :Normal wood (Left) and Compression Wood (right)

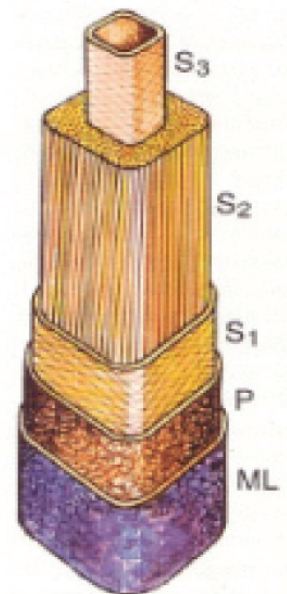
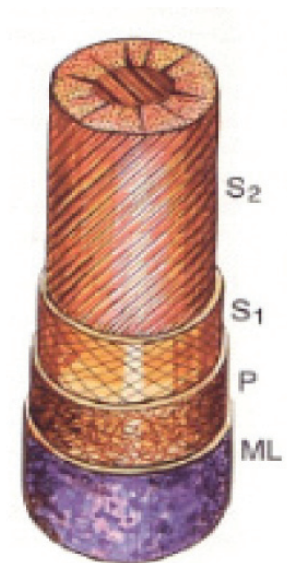
Figure 6: Comparison of cell structure

Normal wood cell

Compression wood cell

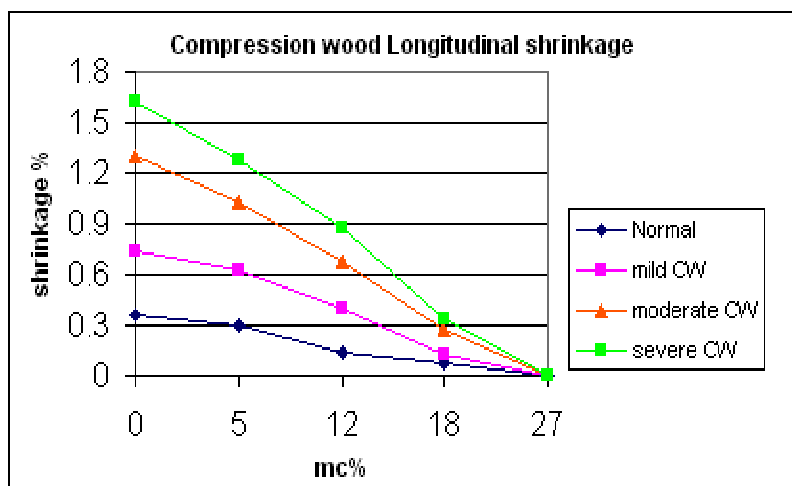
to severe (1%) over the same mc range (figure 7). That means a 2.4 metre length of timber, with severe Compression Wood along its length, could shrink as much as 24mm upon air drying! This is ten times the expansion experienced by a dark steel roof.

Figure 7 Graph showing longitudinal shrinkage, from 'green', of Compression Wood for different levels of severity, compared to normal timber.

Testing done at SCION in 2010 has indicated that shrinkage of as little as 6.5mm can result in the buckling of ridging. It is considered that compression wood with its associated shrinkage movement, is the most likely cause of the increased incidence of buckling of transverse flashings

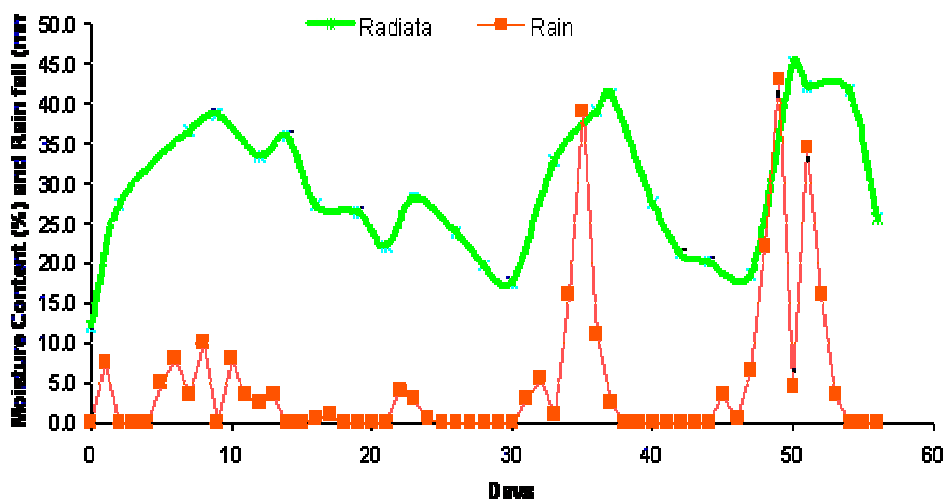
Additionally, when dry Radiata timber is exposed to rain, it can very quickly re-wet above 30% moisture content but take considerably longer

Figure 8 Graph showing average moisture content of exposed framing members (October-December 2003)

to dry back again (Figure 8). Using kiln-dried purlins is only a partial solution
